Hanscom Aero Club Safety Meeting

28 January 2021

- Hanscom traffic pattern review
- Stalls Speeds vs Bank Angle, Weight, Configuration, CG
- Recent accident review N880Z Dec 27, 2021

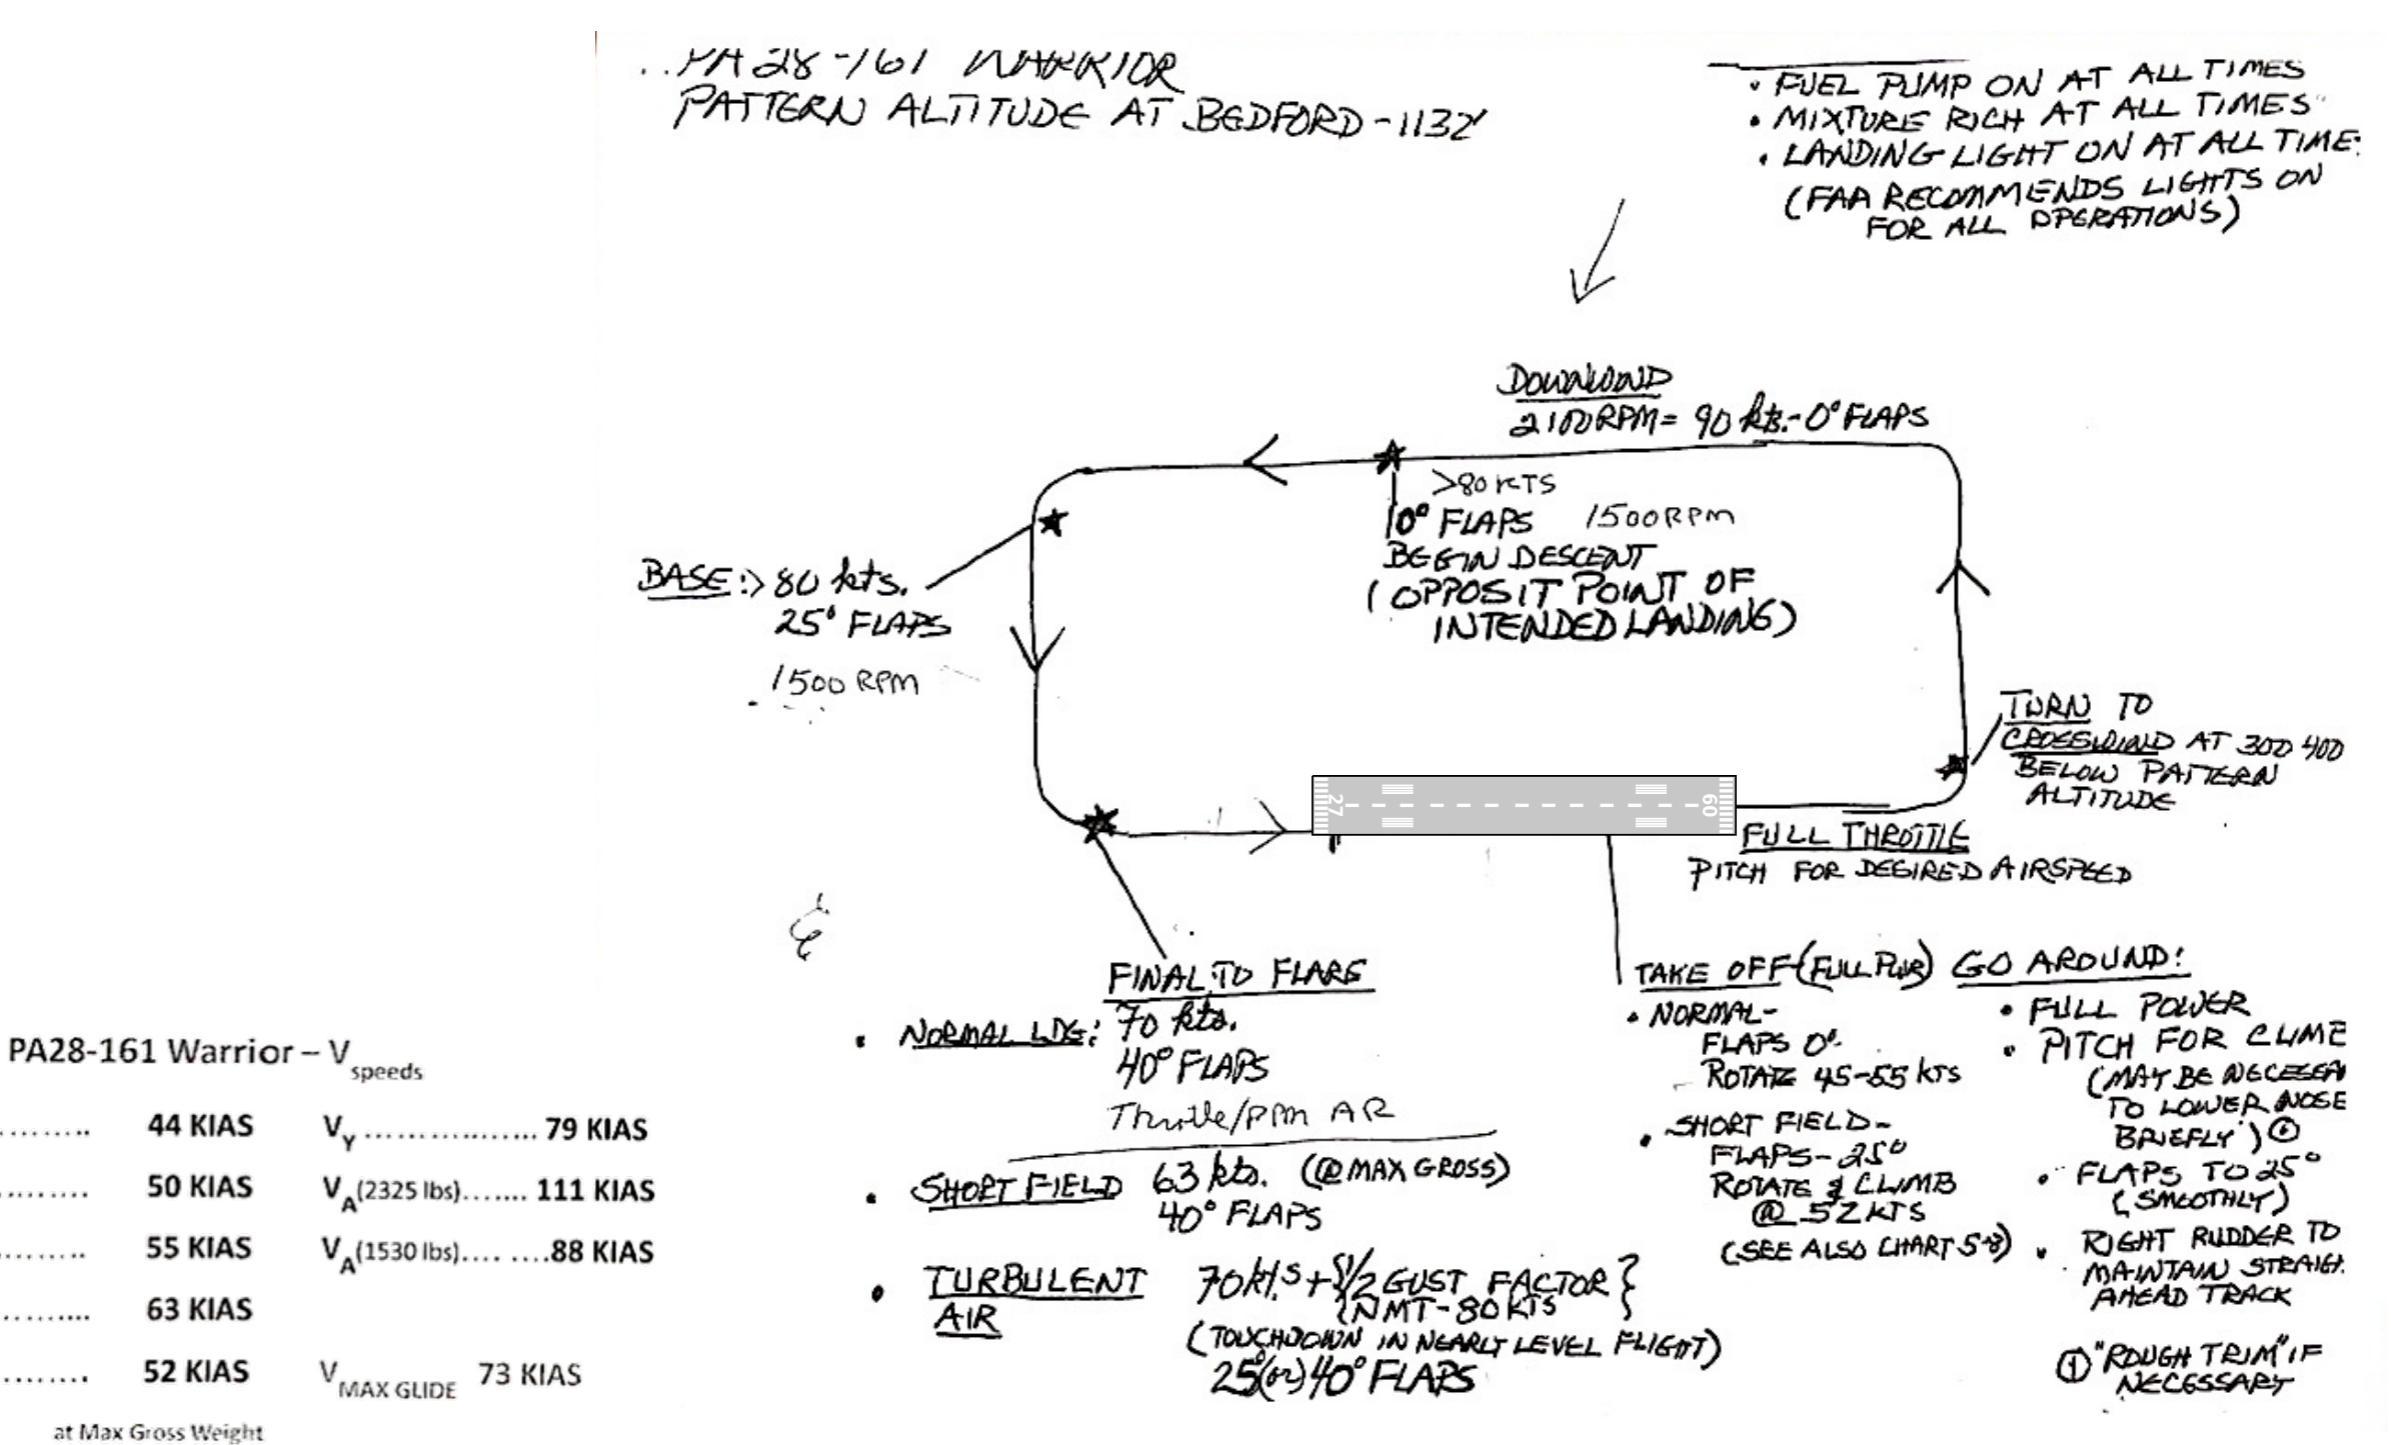
• Ideal pattern airspeeds (kts) in the Warrior: 90, 80, 70

One can find this sheet on the corkboard in the flight planning room

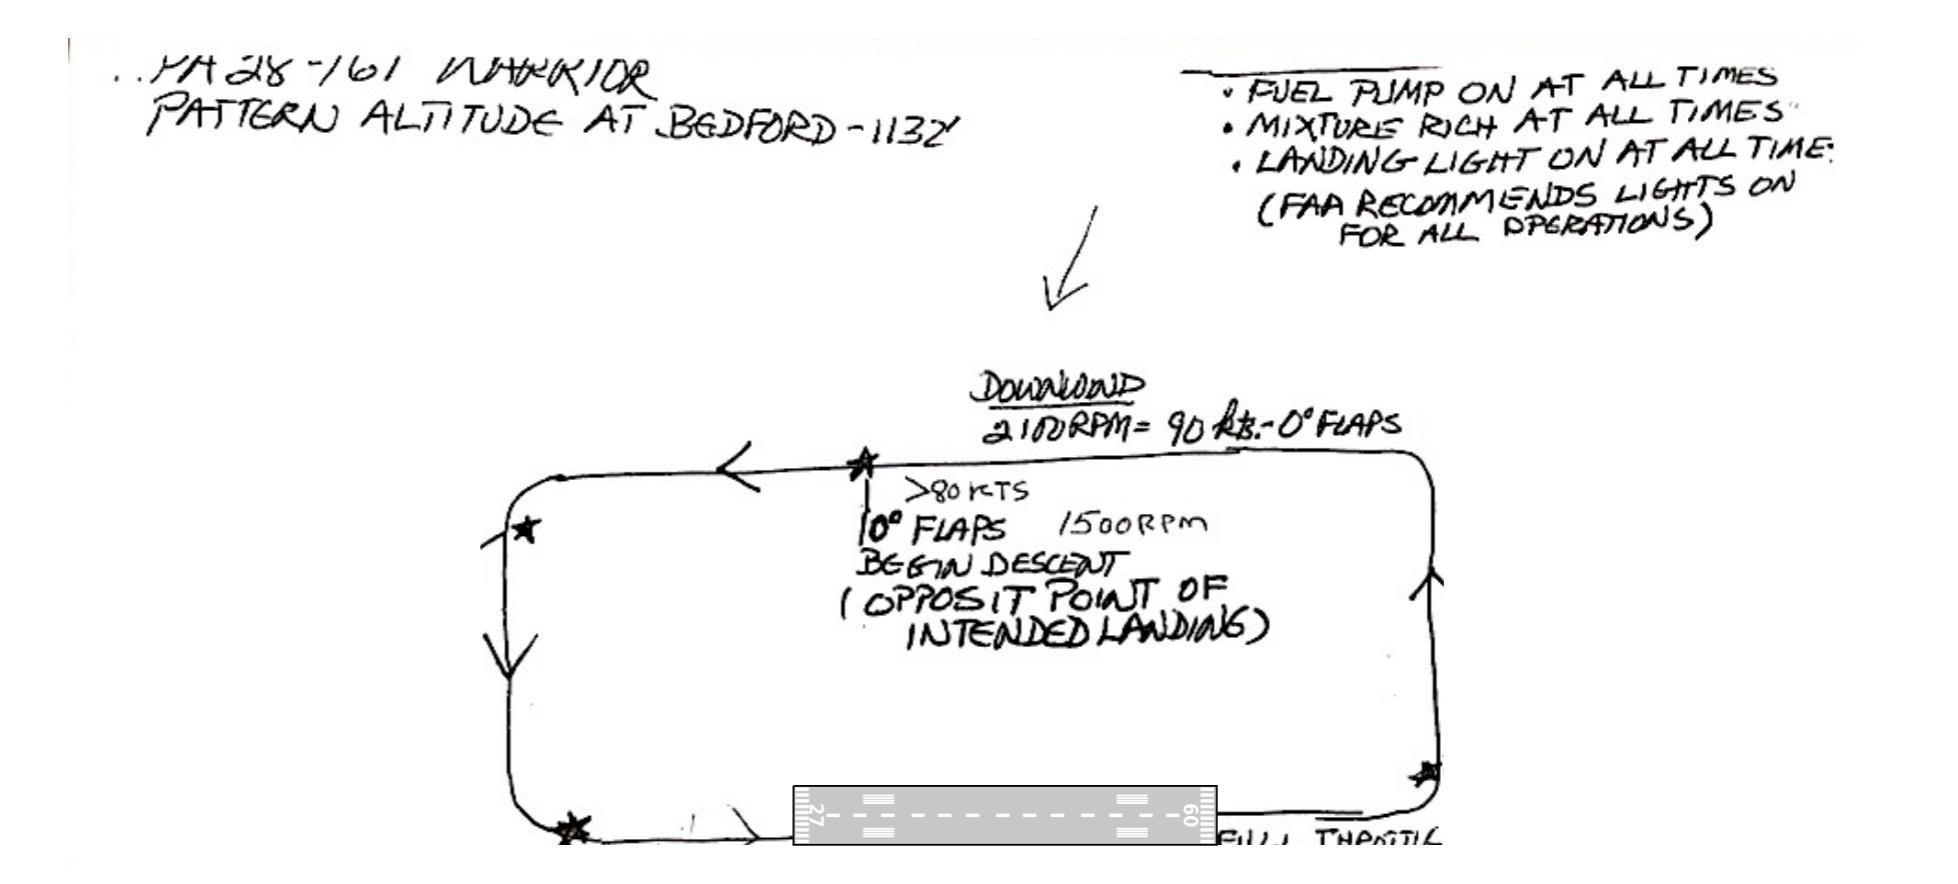
Hanscom Traffic Pattern Guidelines

- Downwind 90 kts
- Power back to 1500 rpm
- 1 notch of flaps when abeam the numbers

Keep to < 20 deg of bank in the pattern to help avoid stalls

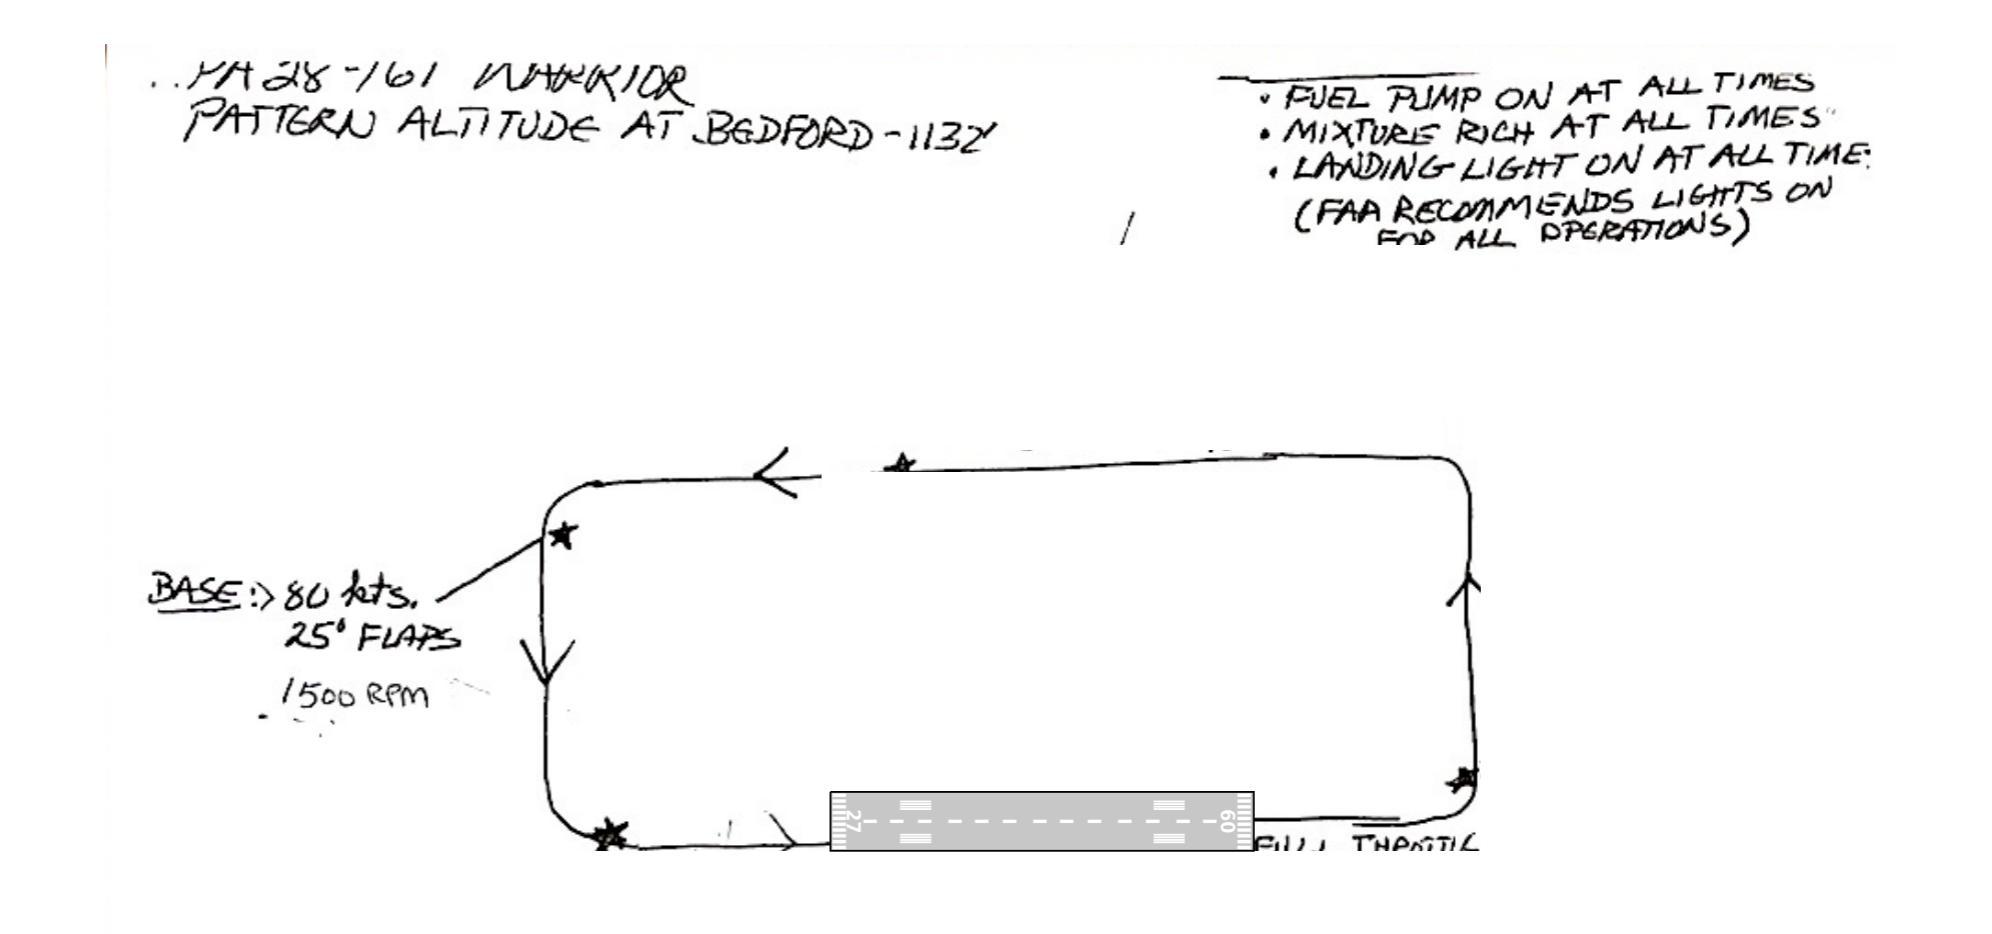
Hanscom Traffic Pattern Guidelines

- Base 80 kts
- 2nd notch flaps
- No more than 20 deg bank angle

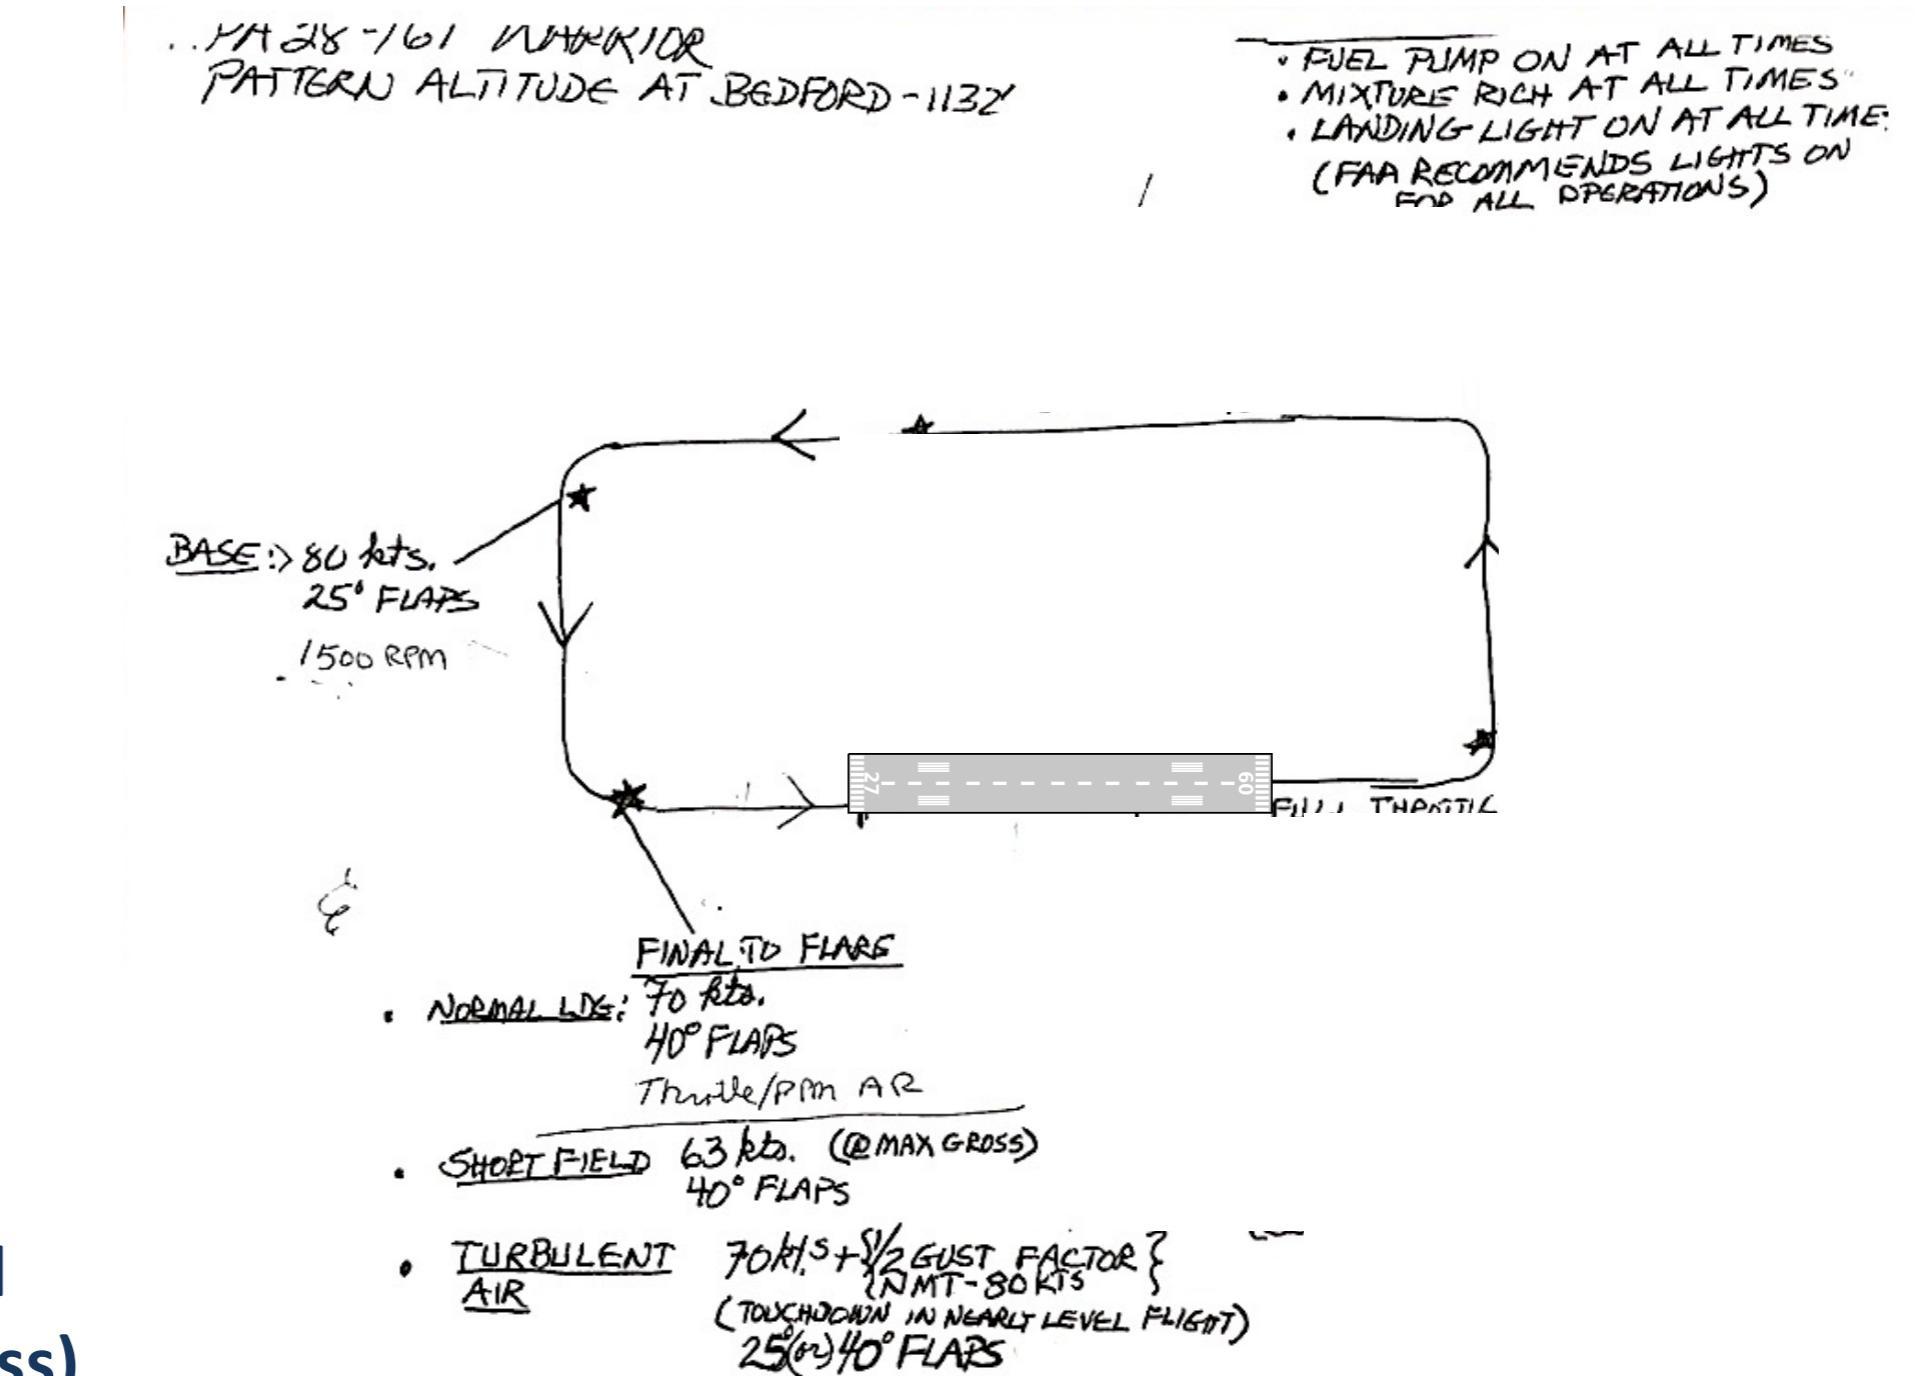
Hanscom Traffic Pattern Guidelines

- Final 70 kts
- ^{3rd} notch flaps
- 63 kts short field final (at max gross)

Try to not exceed 20 of bank in the pattern to help avoid stalls

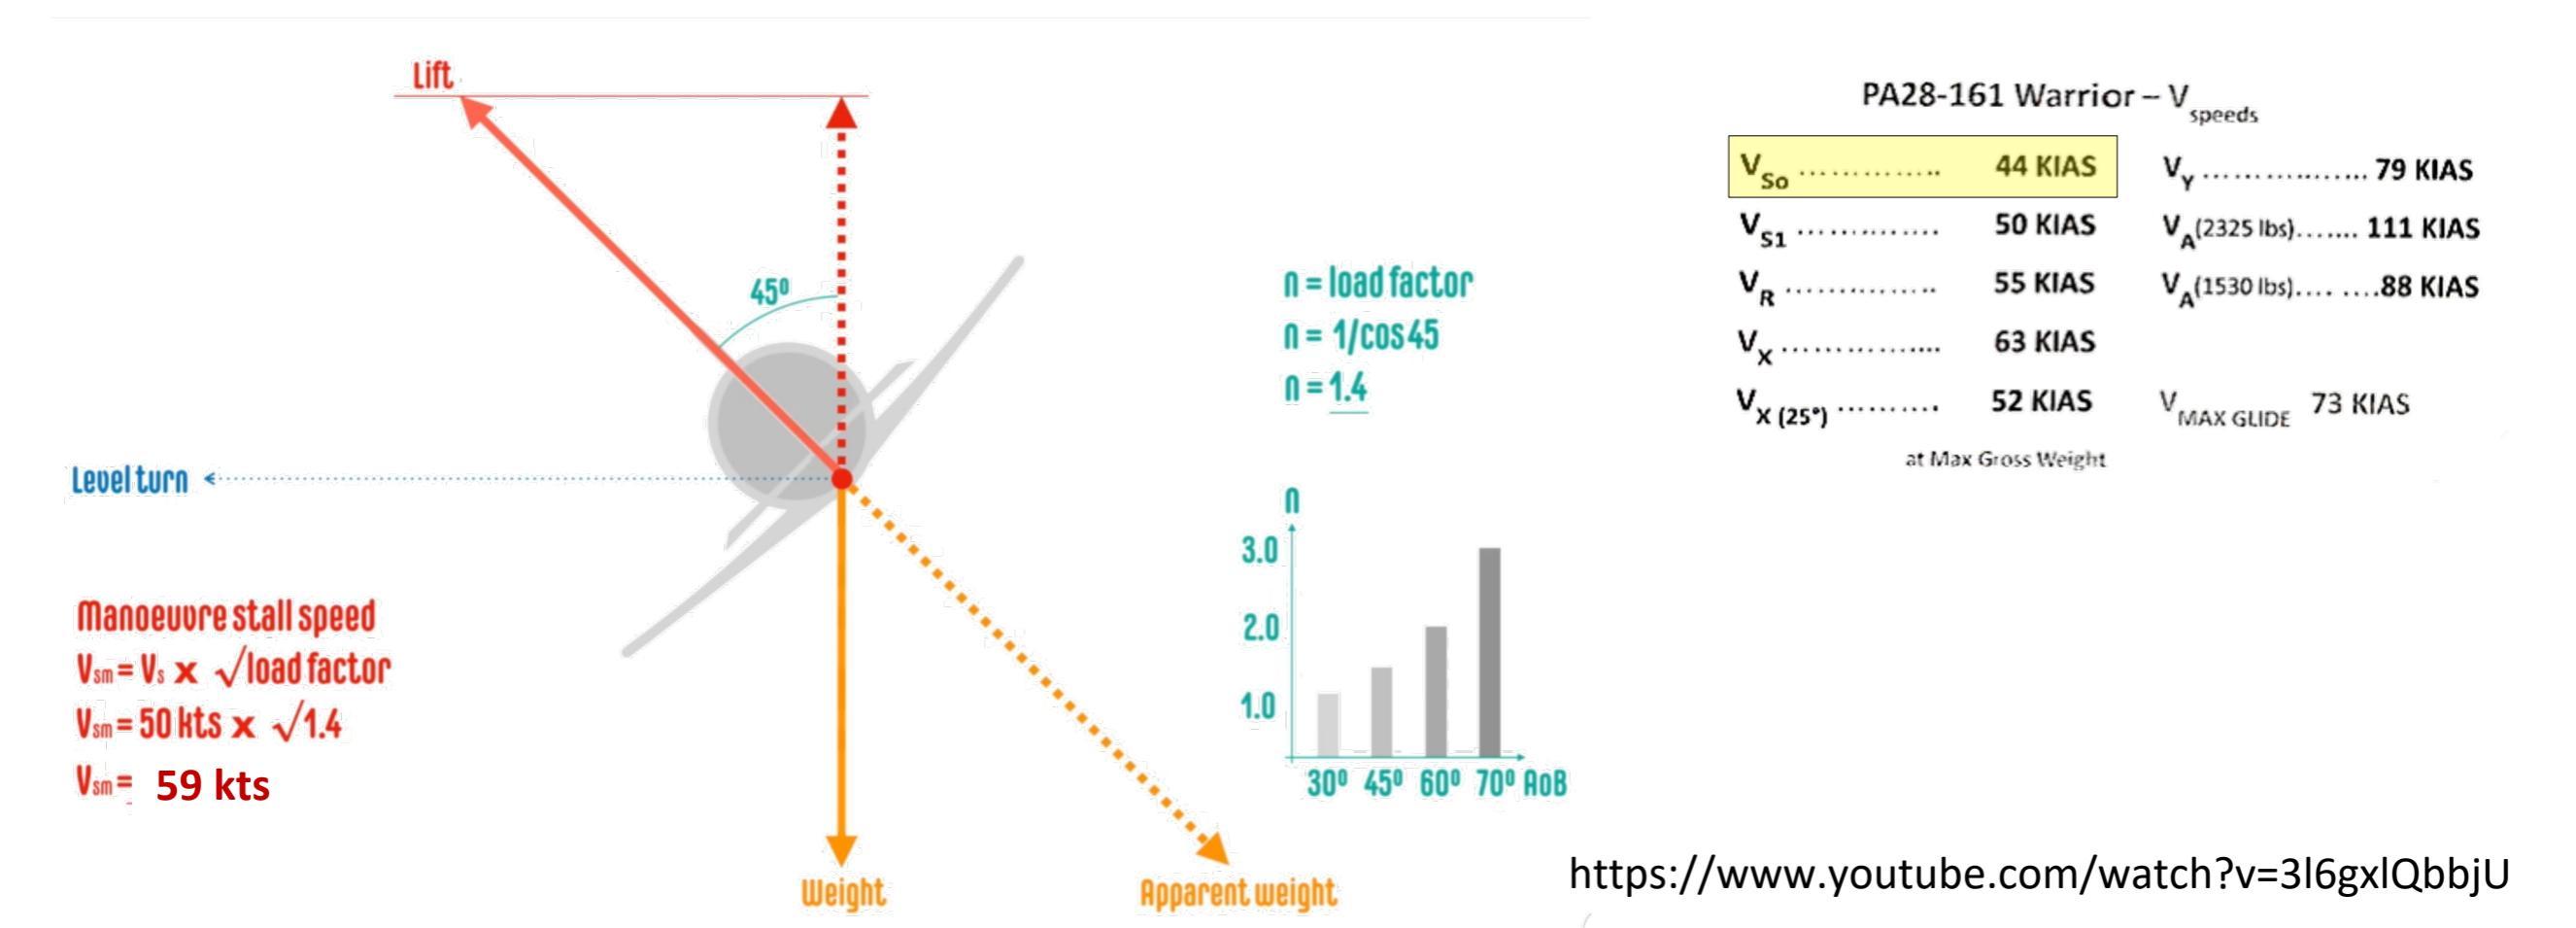
• Stalls occur when the critical angle of attack is exceeded

• An airplane can stall at ANY airspeed!

Example 1	Example 2	Example 3
Angle of Bank	20	30	45
Load Factor	1.064	1.155	1.414
Stall Speed Scalar	1.03	1.07	1.19
Stall Speed (Vs0 = 44)	45	47	52

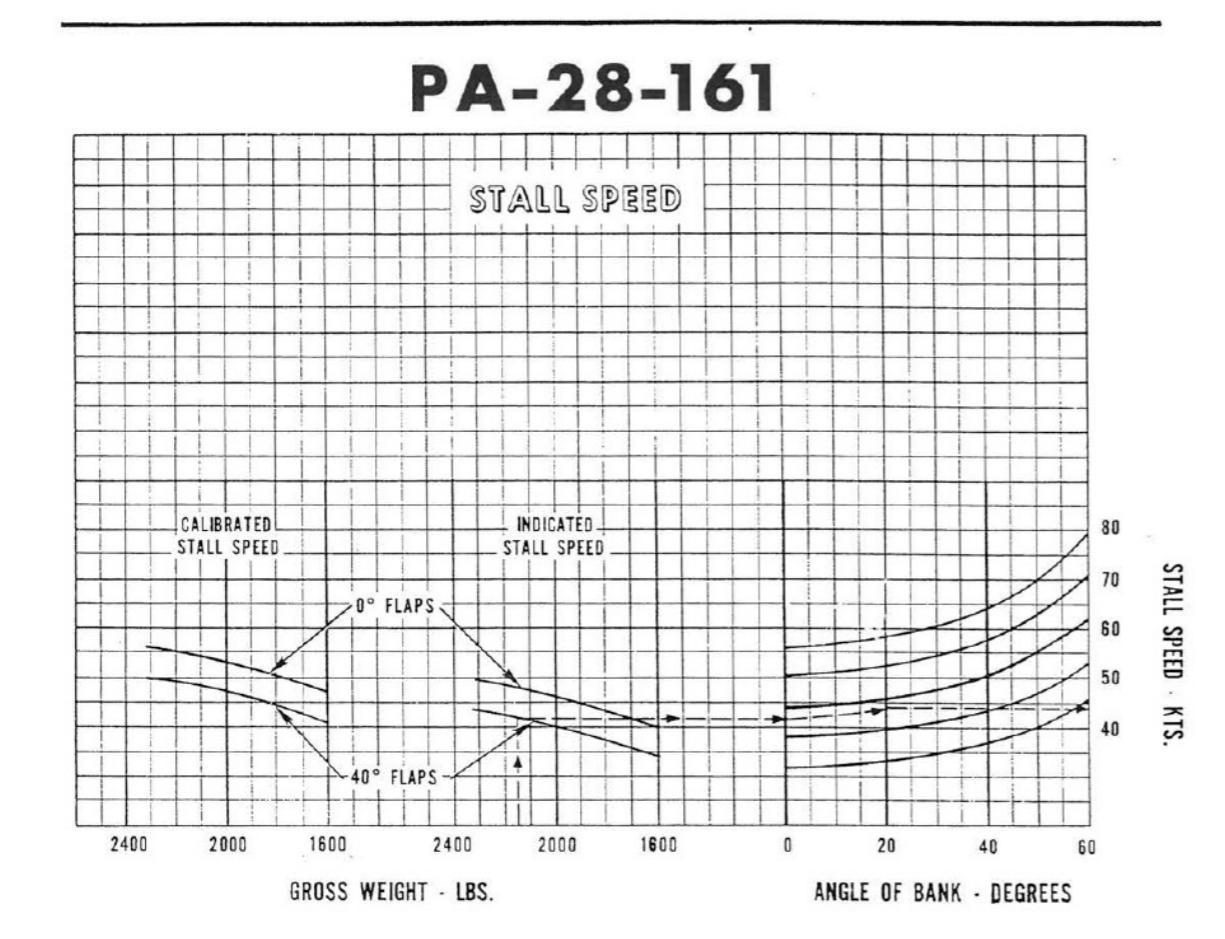
SECTION 5 PERFORMANCE PIPER AIRCRAFT CORPORATION PA-28-161, CHEROKEE WARRIOR II

Example 1	Example 2	Example 3
Pilot/Passenger weight (lbs)	180	360	360
Fuel (gal)	36	48	48
Total weight	1900	2150	2300
Flap Position	0	0	0
Bank Angle (deg)	0	0	0
Stall Speed (kts)	44	48	50

Example: Gross weight: 2170 lbs. Angle of bank: 20° Flap position: 40° Stall speed, indicated: 44 KTS

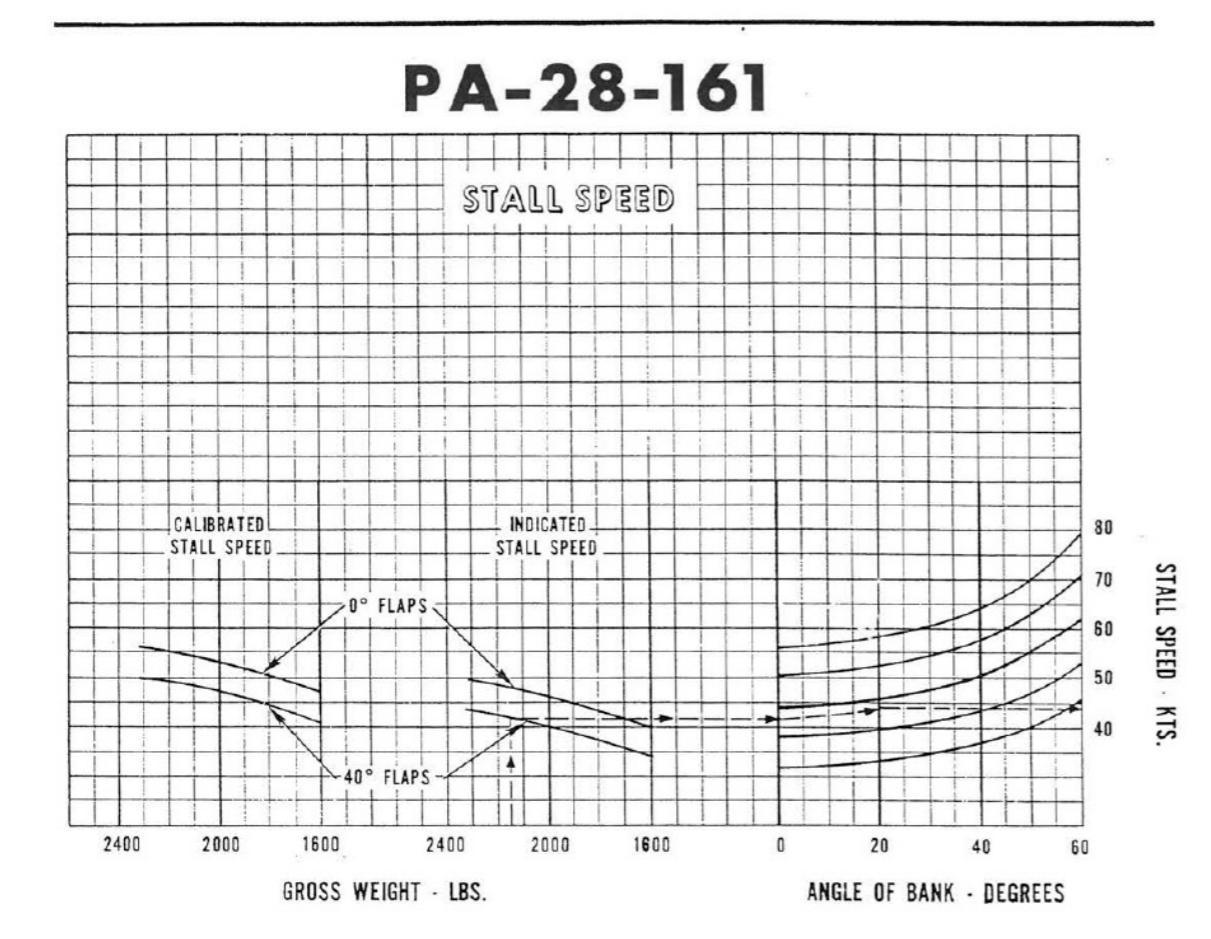
SECTION 5 PERFORMANCE PIPER AIRCRAFT CORPORATION PA-28-161, CHEROKEE WARRIOR II

Downwind to Base	Base to Final
Total weight	2300	2300
Flap Position	10	20
Bank Angle (deg)	20	20
Stall Speed (kts)	50	48

Example: Gross weight: 2170 lbs. Angle of bank: 20° Flap position: 40° Stall speed, indicated: 44 KTS
